INSPECTION REPORT

Meteorological reference: Weather Underground data station, KNMLASCR130. Precip. data 9/13/25

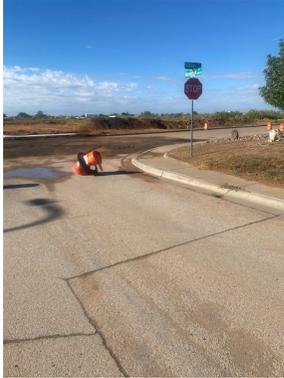
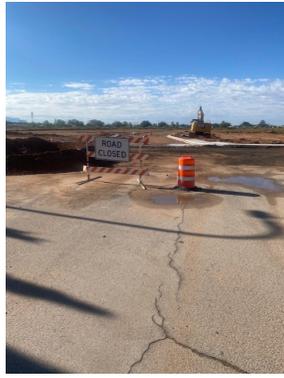
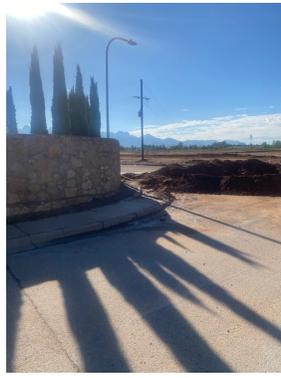
Area of concern: Nunatak at Village Drive. The sediment is maintained within the closed intersection and shows no evidence of escape into drainage system

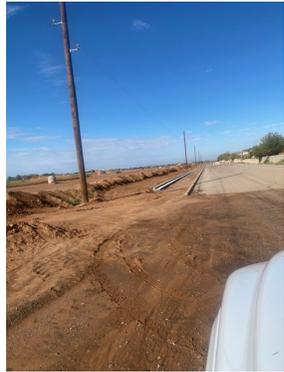
Curb and gutter installed on South side of Village Drive

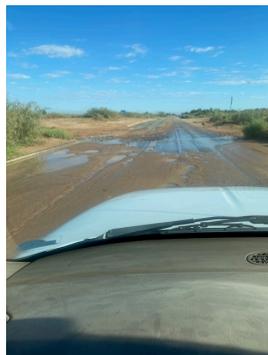
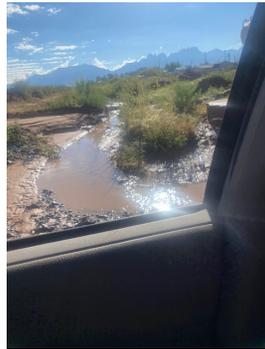
Area of concern: Sediment across Porter post rain event. BMP installed: Cobble check dam at arroyo. Energy dissipation device overwhelmed, sediment discharge onto Porter Road.
