INSPECTION REPORT

Meteorological reference: Weather Underground data station, KNMLASCR560. Precip. data 7/30/25

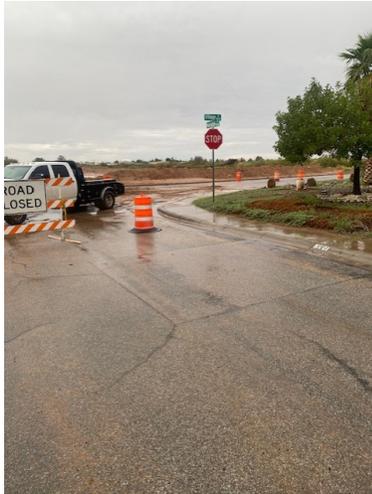
Area of concern from extended rain event: Nunatak at Village Drive. The sediment is maintained within the closed intersection and shows no evidence of escape into drainage system

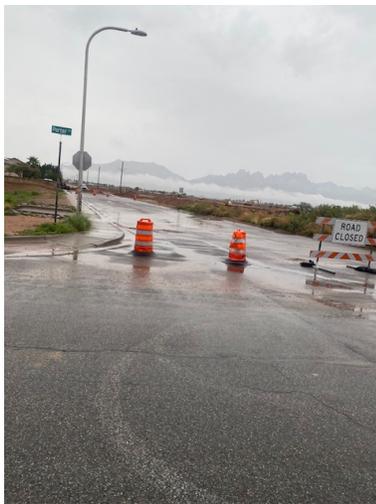
Area of concern from extended rain event: Coyote Flats at Village Drive. The sediment is maintained within the intersection and shows no evidence of escape into drainage system. This sediment is attributable to release from adjacent neighborhood and informal traffic pattern onto Village Drive from subdivision East of construction areas.

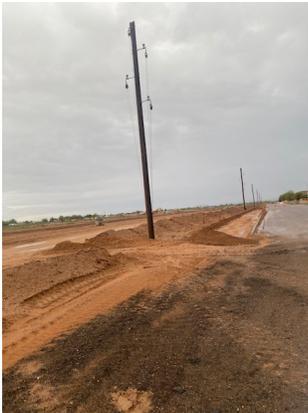
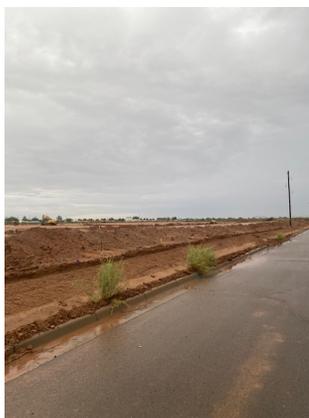
Temporary, Auxiliary entrance at East end of Village Drive used to facilitate EP Electric Co. installation of overhead electrical service to the area. Minor soil migration beyond established entrance to be swept when conditions allow. No intrusion into area drainage.

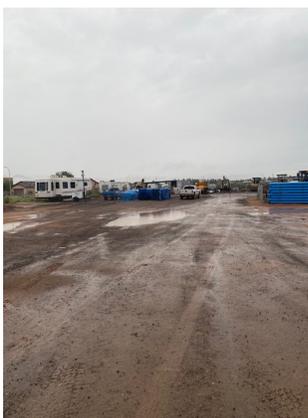
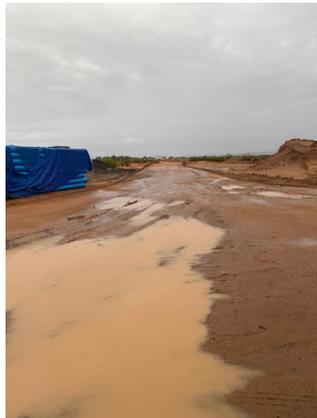
Job site exhibits some minor flooding within the construction area, no runoff of excess water and soil from yard and staging area.
